Inventory Report

DW Inventories Example

Schedule of Cleanliness and Condition

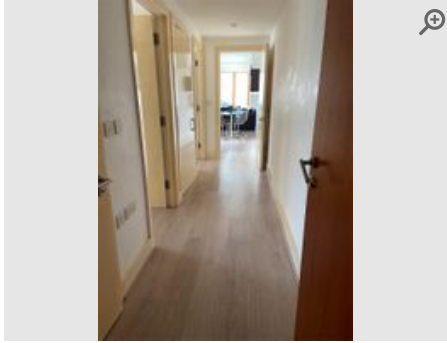
Entrance/Hallway				
Item	Description	Condition	Cleanliness	Photos
General Overview 1.1	Clean and tidy. Neutral smell (no smoking or pet odours).	● Fair	● Good

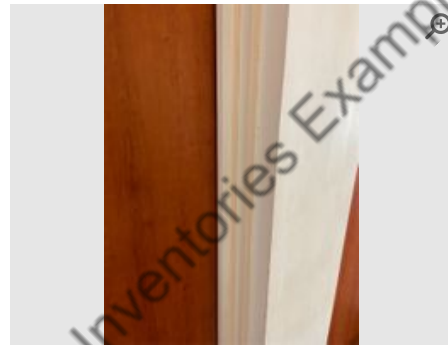
1 photo
Outer Surround 1.2	White painted, wood effect step to bottom; scattered minor chips and scuffs, hairline cracks to left and right, faint marks to upper edge, 1x significant defect to mid left, black marks and worn to step.	● Fair	● Good

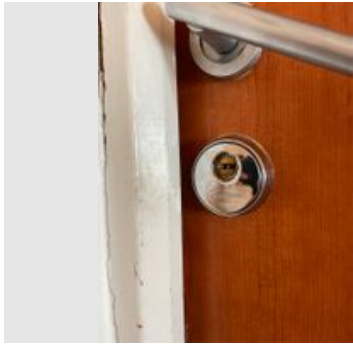
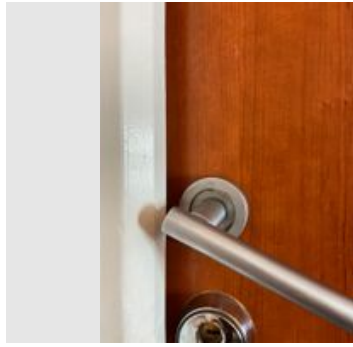
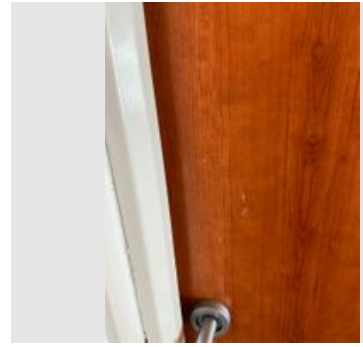
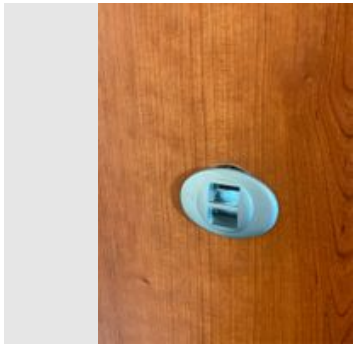
5 photos
Outer Door 1.3	1x wood effect door with: 1x chrome '106', 1x chrome effect plastic spyhole, 1x chrome handle, 1x 'Ezcurra' lock with chrome fixing; peephole fixing is loose and misaligned, scattered white marks above handle, black marks to handle fixing, significant scratches and defects to keyhole fixing, watermarks and scattered scratches to lower section.	● Fair	● Good

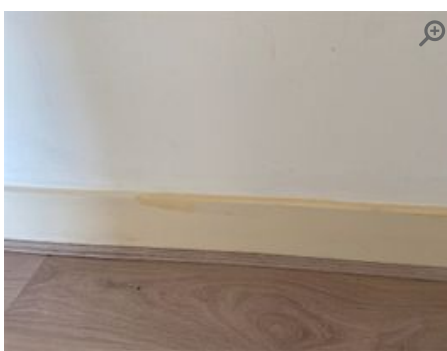
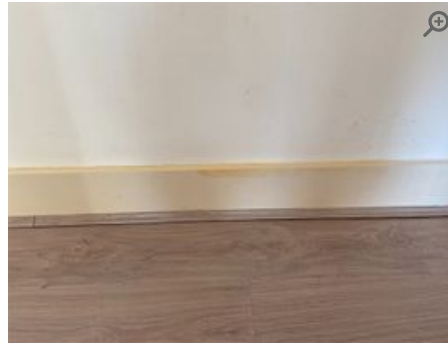
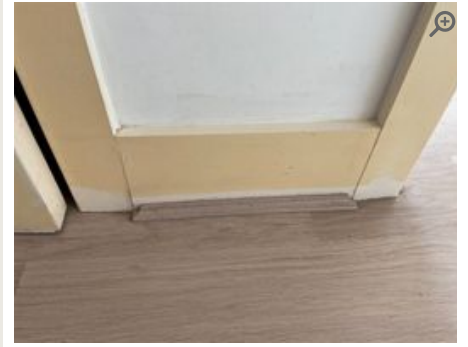
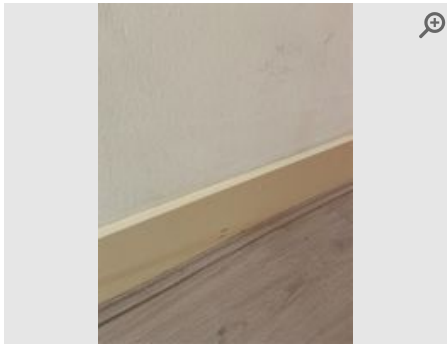
2 photos
Skirting Board 1.7	Magnolia painted; very patchy and discoloured throughout, scattered minor defects, black marks behind entrance door, 1x white paint mark to left of bathroom entrance.	● Fair	● Good

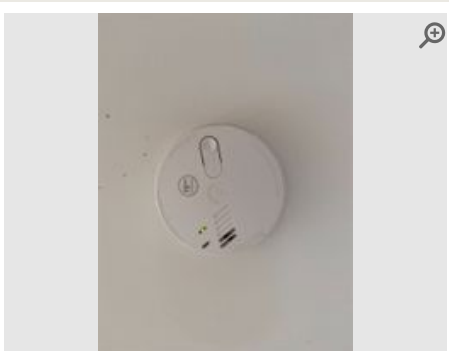
Smoke and Carbon Monoxide Alarm

Gas Appliances: Gas Boiler located to Cupboard in Hallway. Electricity Meter located to Cupboard in Hallway. Smoke Alarms located to: Entrance/Hallway; tested sounder not heard working and Kitchen; tested sounder heard working. Professional Cleaning Receipt dated 10/02/2020

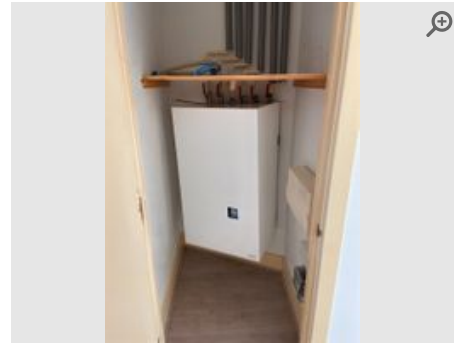
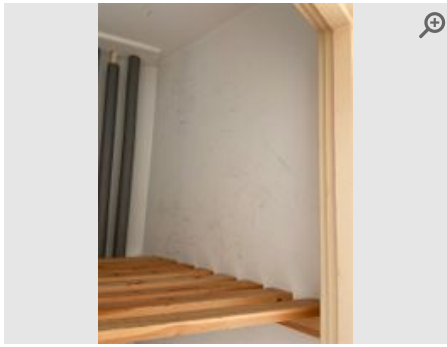
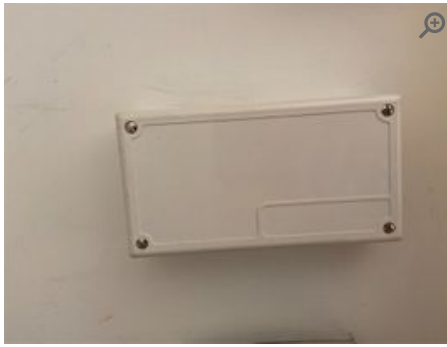
Item	Description	Condition	Cleanliness	Photos
Storage Cupboard/Wardrobe 1.13	1x large built in cupboard with: 1x magnolia painted door with 1x chrome handle and magnolia painted inner and outer surround, magnolia painted to reverse of door, magnolia painted skirting, white painted walls to interior, contains: 1x undecorated wood shelf, 1x 'Switch 2' boiler, 1x consumer unit, 1x electricity meter, 1x BT Openreach point, 2x white plastic blank wall plates, 1x white plastic blank wall plate with fuse, 1x white plastic single switch with fuse, 1x unknown wall mounted unit, 1x spare hose; interior walls are significantly scratched and scuffed particularly to upper right and left, floor is very grubby, 1x large black mark to inner door surround, chips to inner door edge particularly around hinges.

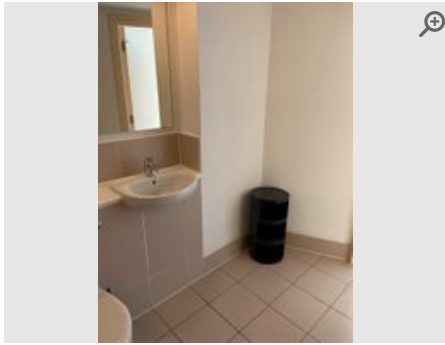
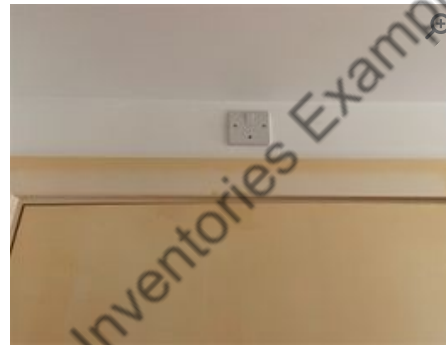
Bathroom				
Item	Description	Condition	Cleanliness	Photos
General Overview 2.1	Clean and tidy. Neutral smell (no smoking or pet odours).	● Fair	● Good	📷 3 photos
Outer Surround 2.2	Magnolia painted; significant discolouration throughout, scuffs to lower right.	● Fair	● Good	📷 3 photos
Outer Door 2.3	1x magnolia painted door with 1x chrome handle and 1x reverse chrome turn lock; scattered chips along upper edge, scattered paint defects to upper section, 1x significant defect to centre, scattered chips and dents to right of handle, paint peeling around handle, grubby to handle and reverse lock, patchy discolouration throughout.	● Poor	● Good	📷 5 photos
Inner Surround 2.4	Magnolia painted; 1x crack to lower right, scattered chips along top inner edge and upper left, grubby to mid left, cracking along left side where surround meets wall.	● Fair	● Good	📷 5 photos
Inner Door 2.5	1x magnolia painted door with 1x chrome handle and 1x chrome turn lock; chipping to centre of upper edge, 1x chip and scattered fingermarks around handle, brown watermarks to upper right, 1x mark to mid right, red scratches next to handle, scattered chips below handle, scattered chips and paint peeling along lower edge, patchy discolouration throughout.	● Fair	● Good	📷 7 photos

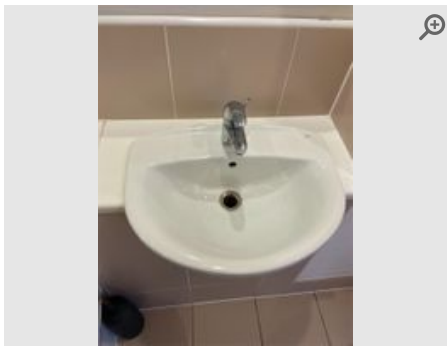
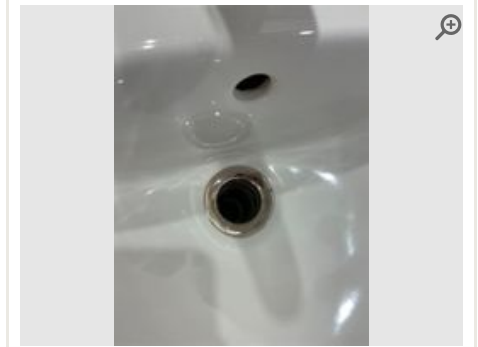
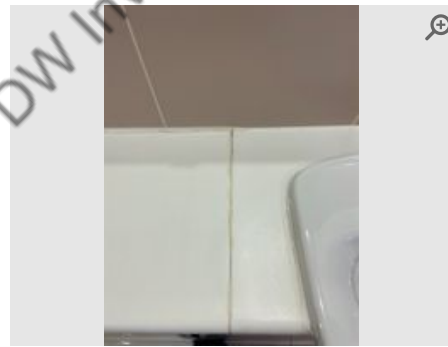
Sink/Basin 2.16	1x white sink mounted in vanity area with 1x chrome mixer tap and 1x chrome plug hole; grouting to vanity area next to sink is discoloured and cracking to left side, sink basin is in good order, minor defects to top of tap, tarnished to plug hole surround, no plug present.	● Good	● Good	📷 5 photos
Toilet 2.17	1x white toilet with white lid and seat and 1x chrome push flush mounted to rear wall; 1x chip to front of lid, 1x minor chip and 1x stain to seat, slightly grubby.	● Fair	● Good	📷 5 photos

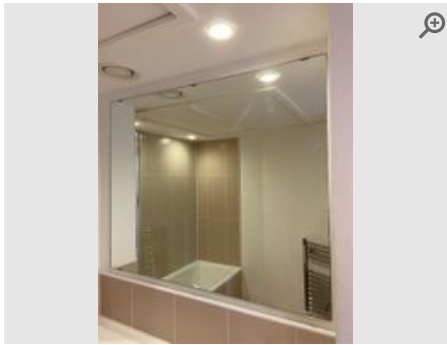
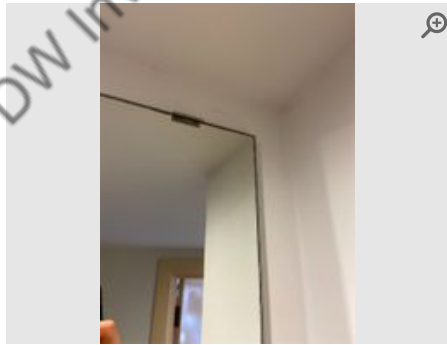
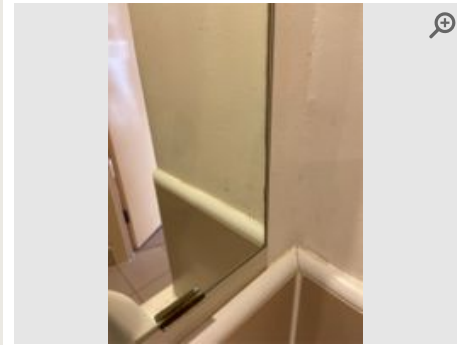
Item	Description	Condition	Cleanliness	Photos
Mirror 2.18	1x large wall mounted mirror behind sink; tarnished to edges, grubby to lower right corner.	● Good	● Good

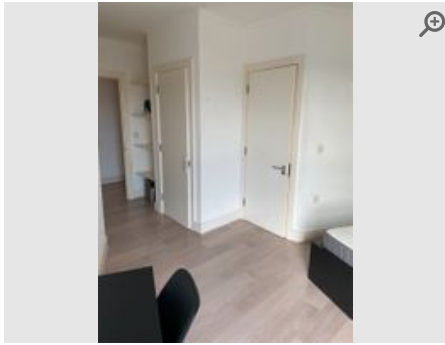
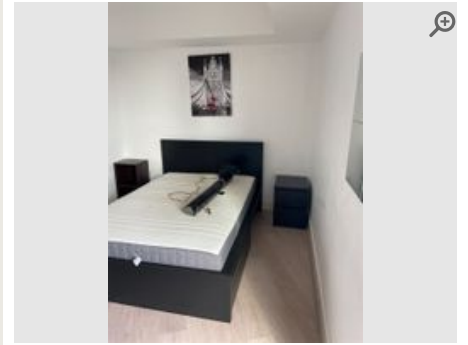
Bedroom				
Item	Description	Condition	Cleanliness	Photos
General Overview 3.1	Clean and tidy. Neutral smell (no smoking or pet odours).	● Fair	● Good	📷 3 photos
Outer Surround 3.2	Magnolia painted; 1x small chip to upper right, 1x defect to upper left corner, scattered circular stains and brown drip marks to lower left and right, patchy and discoloured throughout.	● Fair	● Good	📷 4 photos
Outer Door 3.3	1x magnolia painted door with 1x chrome handle; 1x defect to upper section, scattered linear defects to upper section, paint peeling and chipping around handle, 1x mark to lower mid section, 1x small chip and 1x blue mark to mid right, chipping to upper edge, patchy and discoloured throughout.	● Fair	● Good	📷 7 photos
Inner Surround 3.4	White painted; scuffs to upper left, 1x large discoloured section to lower mid right.	● Fair	● Good	📷 3 photos
Inner Door 3.5	1x white painted door with 1x chrome handle; 1x chip and 1x defect to upper section, scattered chips and drip marks to right of handle, paint chipped and peeling around handle, light scuffs and 1x defect to mid left, scattered chips and grubby to lower section, grubby to hinges.	● Fair	● Fair	📷 6 photos

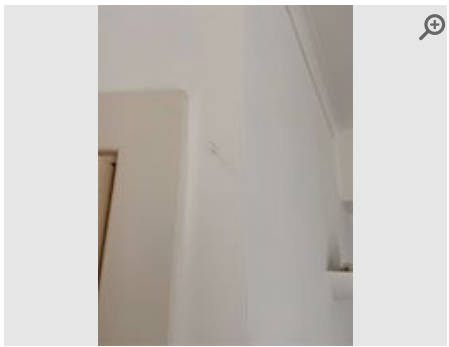
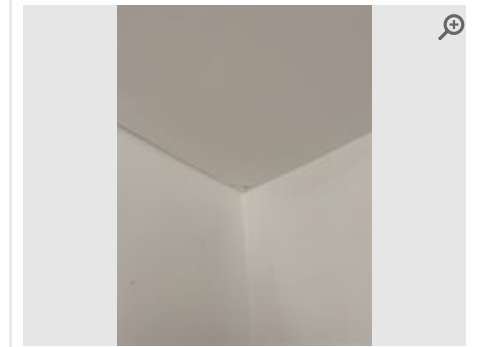
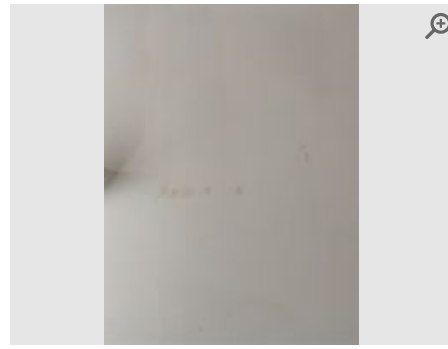
Walls 3.10	White painted; scattered scuffs and chips throughout particularly to shelving area, 1x scuff to upper right of en-suite surround, 1x hairline crack to lower right of en-suite surround, 1x chip to wall left of bed under light, 1x crack and 2x defects to corner upper left of bed, scattered chips to wall to right of bed, scattered paint defects under mirror, multiple defects to right of light above desk, 1x crack to corner to upper right of window, 1x picture hook.	● Fair	● Good	📷 8 photos
Wall Mounted Items 3.11	1x wall mounted bus and bridge motif artwork above bed; good order.	● Good	● Good	📷 1 photo
Ceiling 3.12	White painted; 1x scuff above bed.	● Good	● Good	📷 1 photo
Light Fittings 3.13	3x white wall mounted uplights; dusty, tested and only 1x light working.	● Good	● Fair	📷 1 photo
Sockets & Switches 3.14	1x white plastic double switch, 1x white plastic single switch, 1x white plastic single switch with fuse, 3x white plastic double sockets, 2x white plastic telephone points, 1x white plastic TV/SAT/FM point, 2x white plastic lamp sockets.	● Good	● Good	📷 1 photo

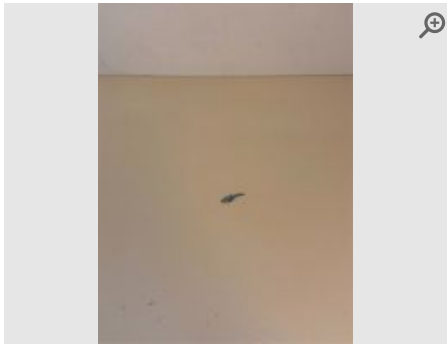
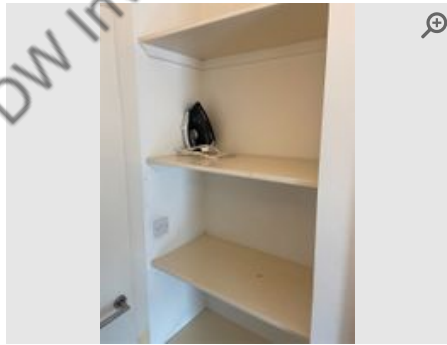
Item	Description	Condition	Cleanliness	Photos
Shelf 3.16	Main shelving area contains 4x white painted shelves with white painted brackets; scattered minor scuffs and chips throughout, 1x significant dent to lower middle shelf, discolouration to underside and edges of shelves, 1x 'Morphy Richards' iron to upper middle shelf. 1x freestanding dark wood effect shelving unit with 2x compartments; scattered minor defects to top, otherwise good order.	● Fair	● Good	📷 6 photos
Desk 3.17	1x black wood effect desk with 2x compartments and 1x small cupboard to bottom; slightly dusty to top, 1x minor defect to cupboard handle and 1x scratch next to handle.	● Good	● Good	📷 2 photos
Deskchair 3.18	1x black plastic roller chair with black padded seat; scattered defects to padded area, slightly grubby to rear, dusty to legs.	● Fair	● Fair	📷 4 photos
Bedside Cabinet 3.19	1x black wood effect bedside cabinet with 2x drawers; slightly grubby to exterior, grubby to both interior drawers.	● Good	● Fair	📷 3 photos

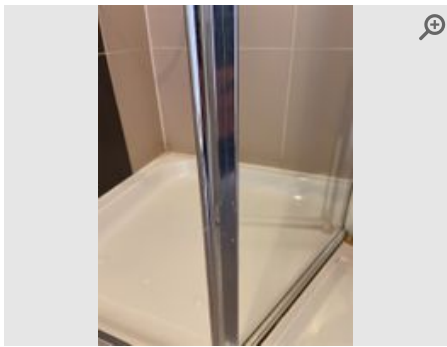
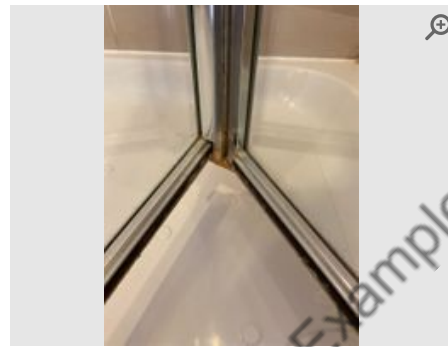
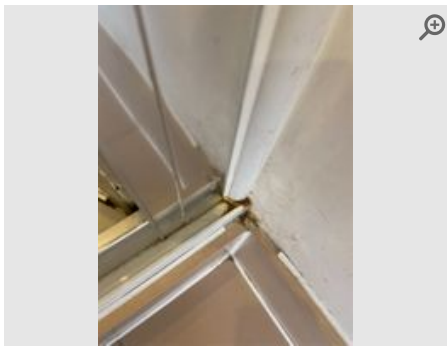
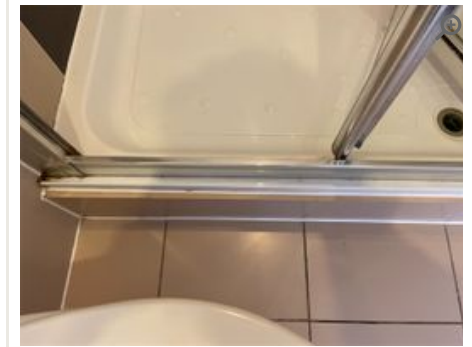
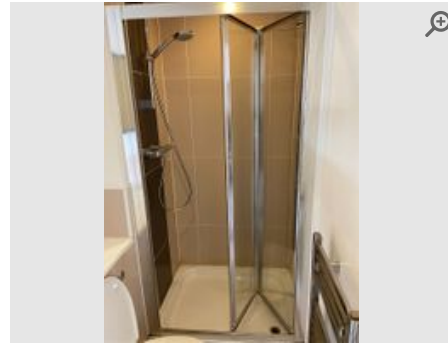
Shower Cubicle/Screen/Tray

Floor 4.6	Grey tiled; discolouration to grouting throughout, otherwise good order.	● Good	● Good	N/A
Skirting Board 4.7	Continuation of floor; slightly grubby.	● Good	● Good	N/A
Walls 4.8	Part white painted, part grey tiled to shower area and behind sink and toilet; staining and scattered chips behind towel rack, 1x brown mark above towel rack, defective area to upper right of cabinet, watermarks behind sink and to left of sink, 1x picture hook, 1x black mark and grubby next to picture hook.	● Fair	● Fair	6 photos
Ceiling 4.9	White painted; 1x large stain next to air vent, 3x marks next to shower.	● Fair	● Fair	3 photos
Light Fittings 4.10	2x spotlights with glass fixings; white paint flecks to both; tested and working.	● Good	● Good	N/A
Sockets & Switches 4.11	1x white plastic shaver socket; slightly loose from wall.	● Fair	● Good	1 photo
Radiator 4.12	1x chrome wall mounted electric heated towel rack; significantly tarnished and rusting particularly to lower section.	● Poor	● Good	2 photos

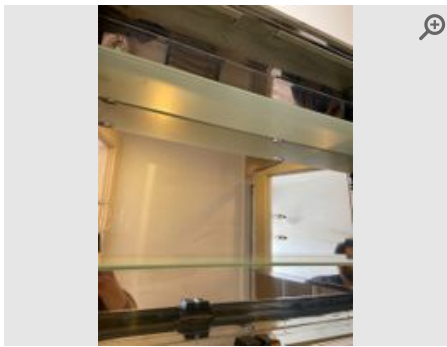
Cabinet 4.18	1x wall mounted chrome cabinet with exterior mirror and 2x push-to-open doors; grubby to interior and tarnished in patches where mirror meets chrome edges.	● Fair	● Fair	3 photos

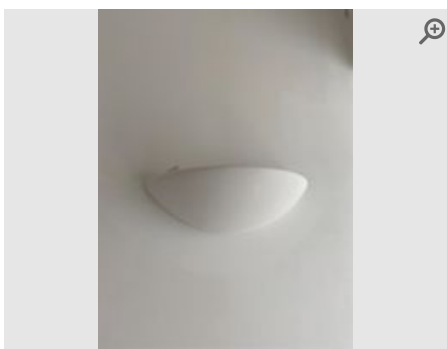
Ceiling 5.12	White painted; 1x small crack to right of window.	● Good	● Good	📷 1 photo
Light Fittings 5.13	2x white wall mounted uplights; dusty, not working.	● Fair	● Fair	📷 1 photo
Sockets & Switches 5.14	1x white plastic double switch, 5x white plastic double sockets, 1x white plastic telephone point, 1x white plastic double telephone point, 1x white plastic TV/SAT/FM point, 2x white plastic lamp sockets.	● Good	● Good	📷 1 photo
Storage Cupboard/Wardrobe 5.15	1x built-in cupboard with: white painted surround, 2x white painted sliding doors (each with 1x chrome handle), 1x white painted interior shelf, 1x chrome clothes rail with various hangers, 1x chip to centre of lower edge of left side door, 1x significant chip and paint peeling to lower right corner of right side door, scattered scratches and scuffs to interior walls, scattered scuffs to lower section of right side door, 1x large significant defect to upper section of left side door.	● Poor	● Good	📷 8 photos

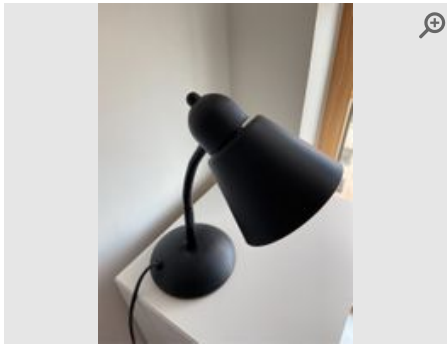
Shelf 5.16	1x dark wood effect wall mounted shelves with 2x compartments; good order. 1x white and dark wood effect freestanding shelving unit with 2x compartments; slightly grubby to near right corner of top face.	● Good	● Good	📷 3 photos
Drawers 5.17	1x blue wood effect set of drawers with 2x drawers (each with dark chrome knobs); scattered chips to upper front edge and to face of drawers, scattered white marks along front right leg and to left side face, grubby to upper drawer. 1x black set of drawers with 3x drawers (each with chrome and diamond effect pull handles); defective along top edge of bottom drawer.	● Fair	● Good	📷 7 photos
Lamp 5.18	1x small black lamp with bulb; good order.	● Good	● Good	📷 1 photo

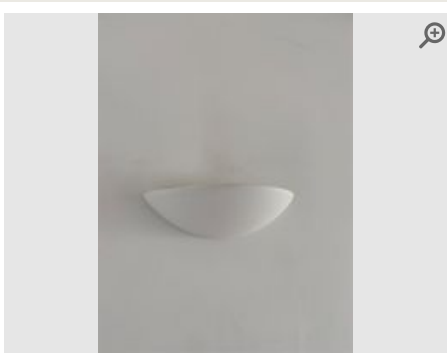
Ceiling 6.11	White painted; scattered scuffs and marks to centre.	● Good	● Good	📷 3 photos
Light Fittings 6.12	3x white wall mounted uplights; dusty, not working.	● Fair	● Fair	📷 1 photo
Sockets & Switches 6.13	1x white plastic triple switch, 1x white plastic single switch, 3x white plastic double sockets, 1x white plastic single socket, 2x white plastic telephone points, 1x white plastic TV/SAT/FM unit, 1x white plastic lamp socket; single socket behind sofa is loose from wall.	● Fair	● Fair	📷 2 photos
Sofa 6.14	1x leather effect corner sofa, 4x leather effect pillows, 5x fabric pillows, 4x seat cushions; 1x defect to inside corner, scattered small stains.	● Fair	● Fair	📷 4 photos
Coffee Table 6.15	1x black coffee table with glass top and 1x interior shelf; 1x unidentified paper under glass, grubby to interior.	● Fair	● Fair	📷 4 photos
TV Cabinet 6.16	1x dark wood effect TV cabinet with 1x shelf to left side; missing shelf to right side, minor chips to front edge of shelf.	● Good	● Good	📷 2 photos

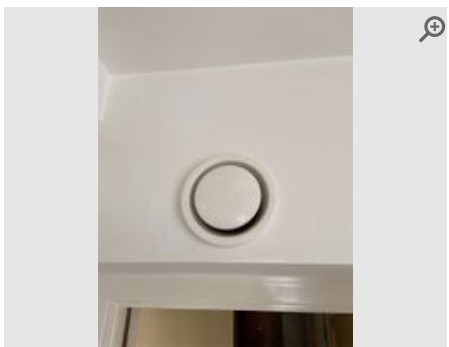
**Extractor
Fan**

Item	Description	Condition	Cleanliness	Photos
Extractor Fan 6.20	1x white plastic air vent above doorway; good order.	● Good	● Good

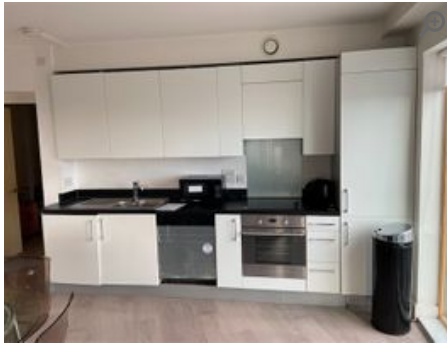
Kitchen				
Item	Description	Condition	Cleanliness	Photos
General Overview 7.1	Clean and tidy. Neutral smell (no smoking or pet odours).	● Good	● Good	📷 1 photo
Floor 7.2	Light wood effect laminate continuation of hallway; small scattered chips in front of dishwasher, scattered scuffs to right side in front of freezer.	● Fair	● Good	📷 2 photos
Walls 7.3	White painted, obscured glass section to rear of hob; grubby and fingermarks throughout.	● Good	● Fair	📷 3 photos
Ceiling 7.4	White painted; slightly grubby around fire alarm.	● Good	● Good	📷 1 photo
Light Fittings 7.5	3x chrome downlights mounted under wall units; grubby, right side light missing bulb, none working.	● Fair	● Fair	📷 3 photos
Sockets & Switches 7.6	1x white plastic multi-switch unit for white goods, 3x double sockets, 1x oven switch, 1x blank wall plate; good order.	● Good	● Good	📷 1 photo
Kitchen Base Units 7.7	3x white base units (each with 1x chrome handle) left to right; Left side unit: 2x sticky residue to reverse door of left side unit, contains washing machine, doors misalign. Middle unit: houses sink basin, minor chips to lower interior edge and lower door edge, contains 1x frying pan and 1x plate. Right side unit: 1x interior shelf, contains 1x blender and 1x electric toastie maker, 1x white plastic single socket.	● Fair	● Good	📷 6 photos

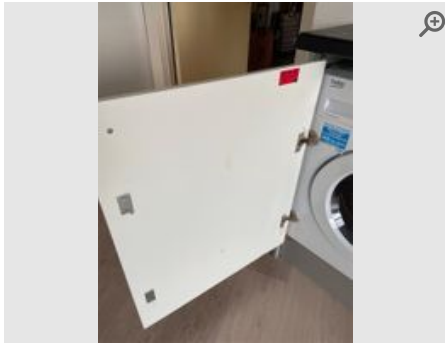
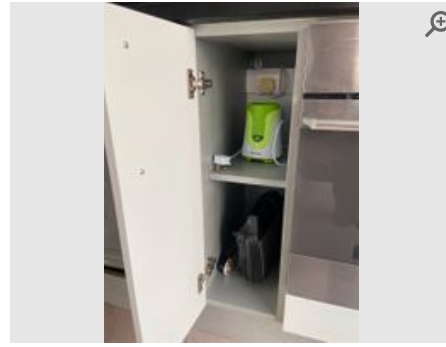
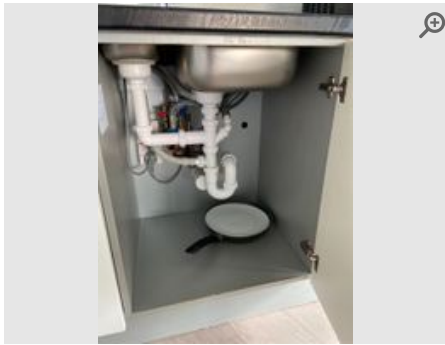
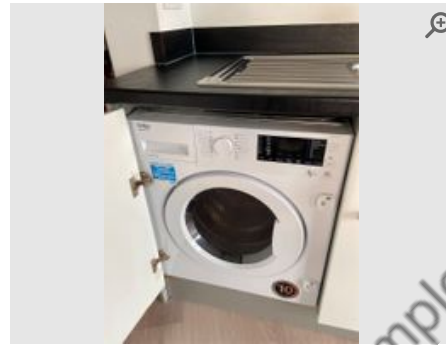
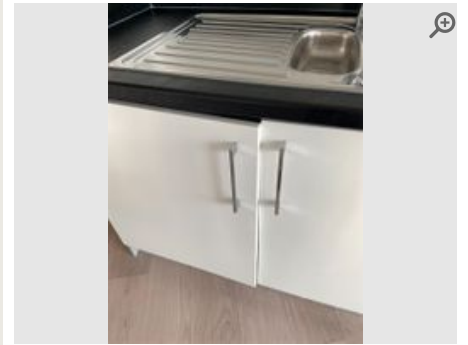
Kitchen Base Units

Kitchen Drawers 7.10	3x white shelves (each with 1x chrome handle); first drawer contains 1x bulb and scattered minor chips to front face, other shelves are good order.	● Good	● Good	📷 6 photos
Kitchen Worksurfaces 7.11	Black work surface; 1x small white chip to left of hob.	● Good	● Good	📷 1 photo
Kitchen Sink 7.12	Chrome 1.5 bowl sink with: 1x chrome mixer tap, 1x chrome draining board; watermarks to main sink basin, water pooling to smaller sink.	● Good	● Good	📷 4 photos
Hob 7.13	1x black electric hob with 4x ring burners and 4x chrome dials; front left burner is slightly discoloured, minor chipping to left side of hob frame.	● Fair	● Good	📷 4 photos
Oven 7.14	1x chrome and black 'Electrolux' oven with: 2x chrome dials, 3x chrome buttons, 2x wire racks to interior; 1x small chip to white panel below, 1 black mark to lower edge of oven, watermarked to chrome fixings.	● Good	● Good	📷 6 photos

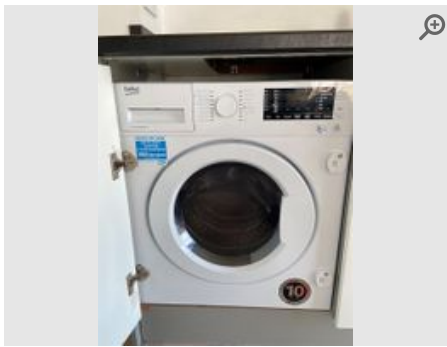
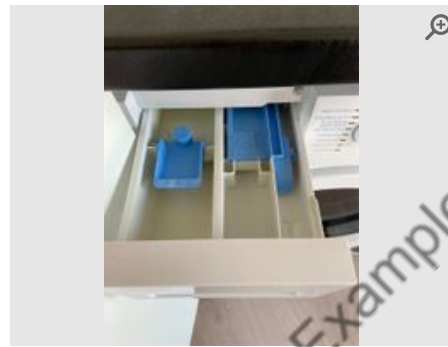
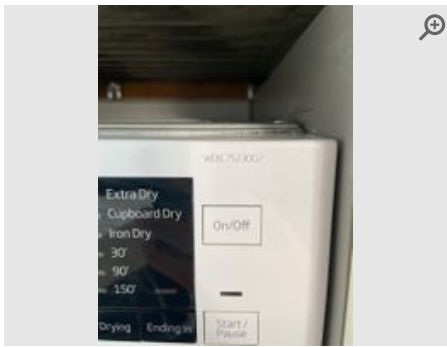
Item	Description	Condition	Cleanliness	Photos
Washing Machine 7.19	1x white 'Beko' washing machine housed within left side base unit, slightly watermarked to inner rubber seal, otherwise good order.	● Good	● Good	📷 4 photos
Dishwasher 7.20	1x dishwasher; missing front unit face, contains 2x racks and cutlery compartment, clean inside, watermarked to reverse of door, detergent tablets in both compartments.	● Good	● Fair	📷 4 photos
Miscellaneous 7.21	1x black toaster, 1x black kettle, 1x chrome and black electric bin; all slightly grubby, toaster tarnished to metal, limescale to kettle. 1x chrome handle loose on kitchen work surface, Professional Cleaning Receipt dated 10/02/2020	● Good	● Fair	📷 8 photos
Fire Alarm 7.22	1x white plastic ceiling mounted smoke alarm; tested and sounder heard working.	● Good	● Good	📷 1 photo

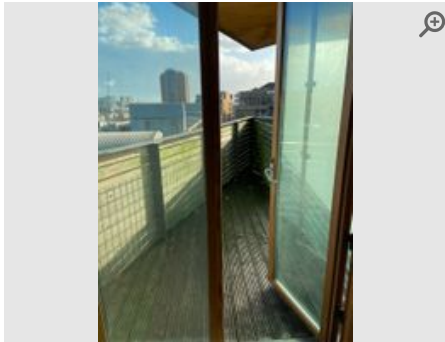
Item	Description	Condition	Cleanliness	Photos
General Overview 8.1	Balcony area to far side of living room.	● Fair	● Fair	📷 2 photos
Door (Internal) 8.2	1x back door and window with: white surround, wood effect frame, white sill, 1x chrome handle and 1x chrome turn lock to door, 2x glass panes; inner wood frame discoloured to bottom, grubby with scattered chips to sill, grubby to glass panes, defective around door latch, scratches to door handle fixing.	● Fair	● Fair	📷 7 photos
Floor 8.3	Wood decking; very grubby and discoloured, debris to far side, fair seasonal order.	● Fair	● Fair	📷 2 photos
Walls 8.4	Wood and metal wall to left side, partial wood and obscured glass and chrome to right side; fair seasonal order.	● Fair	● Fair	📷 4 photos
Ceiling 8.5	Orange roofing partially covering balcony area; very grubby.	● Fair	● Poor	📷 2 photos
Light Fittings 8.6	1x outdoor light; grubby, tested and working.	● Fair	● Fair	📷 1 photo
